NATICK/76-062 - CEMEL

**FLAME TEST FOR MEDICAL UNIT,
SELF-CONTAINED TRANSPORTABLE
(INFLATABLE SHELTER ASSEMBLY)**

24 June 1977

UNITED STATES ARMY
NATICK RESEARCH and DEVELOPMENT COMMAND
NATICK, MASSACHUSETTS 01760

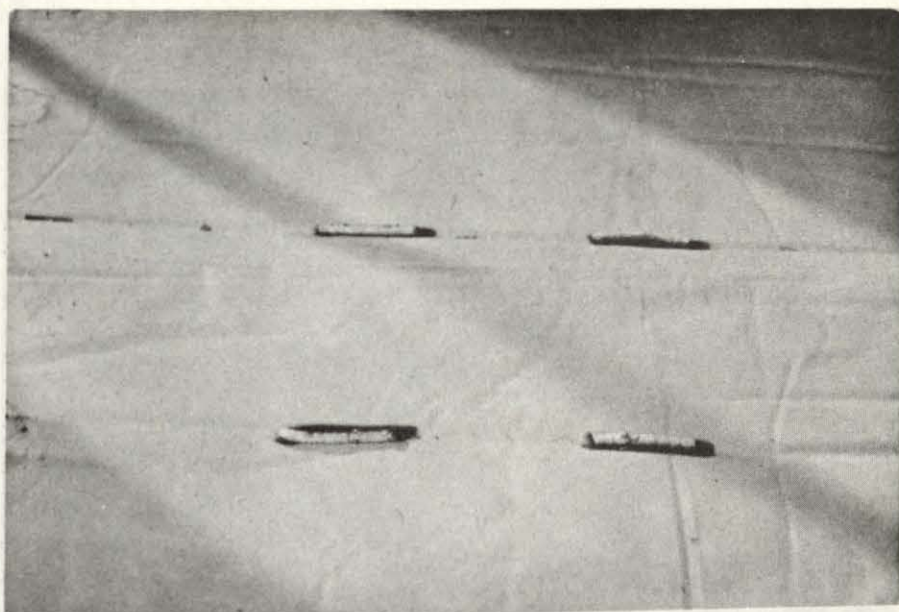
1. Cigarette test. All six shelters were subjected to the cigarette test. Four lighted cigarettes were placed on the floor of the MUST Shelter and allowed to burn to the end (see Figure 3). The cigarettes charred the floor without any flaming.

Figure 3. Effects of Lighted Cigarettes on MUST Shelter Floors

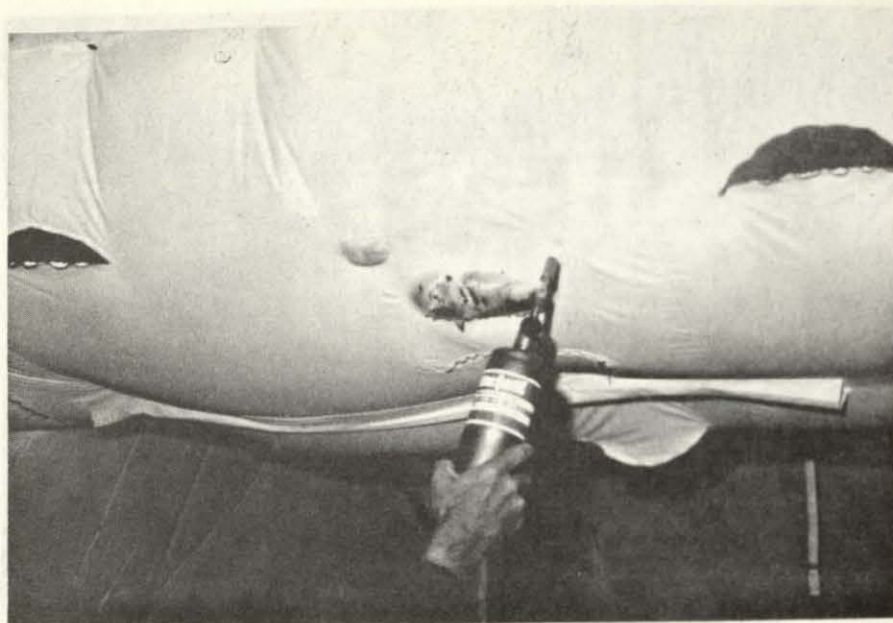
2. Torch test. All six shelters were subjected to the torch test. The air-conditioning distribution plenum was subjected to the flame of a propane torch for 10 seconds (see Figure 4). The coated fabric melted, with slight charring, but did not ignite.

Figure 4. Effects of a Propane Torch on the Air Distribution Plenum.

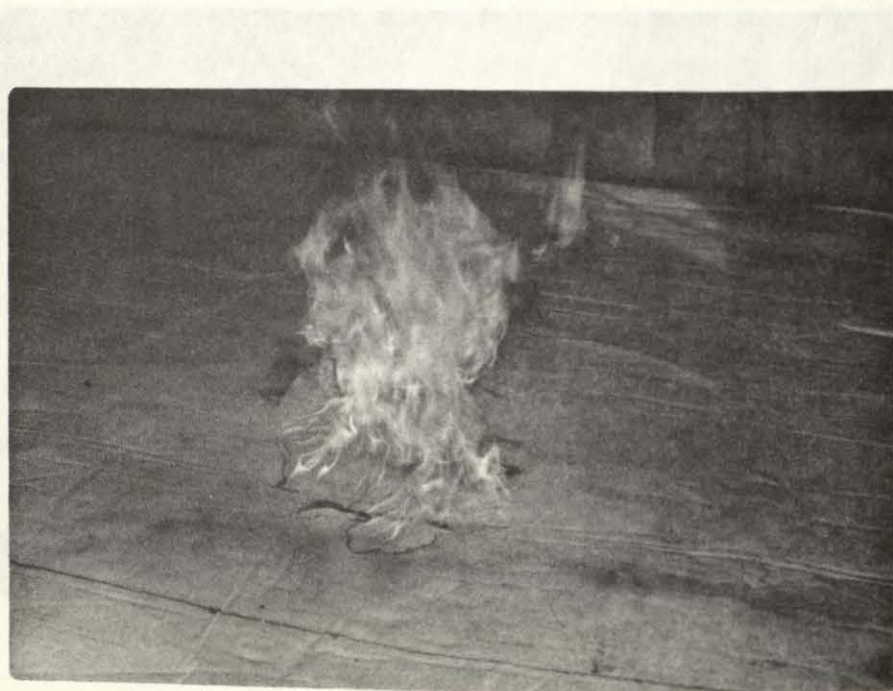
Figure 5. Effect of a Spilled Alcohol Fire, Immediately After Ignition.

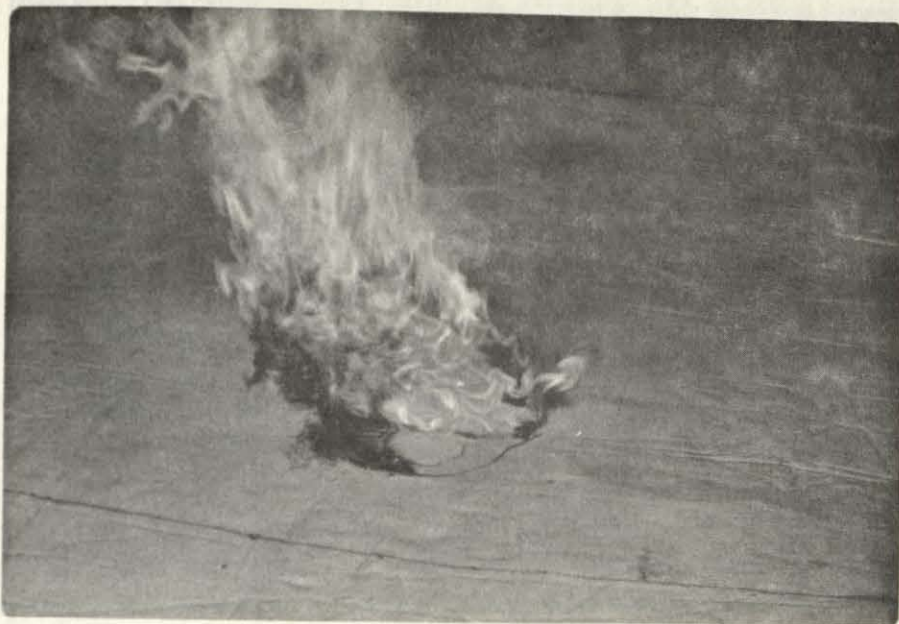
after ignition, dense black smoke was produced (see Figure 6) and increased in density (see Figures 7 and 8) so that the shelter was usually evacuated by test personnel within 60 seconds of ignition. The fire did not spread rapidly during the test, but in general contained itself to an area of 3 feet (.915 m) in diameter (see Figure 9) and appeared to be self-extinguishing. The residual fire was easily extinguished with a carbon-dioxide fire extinguisher.

Figure 6. Effect of an Alcohol Fire, 30 Seconds After Ignition.

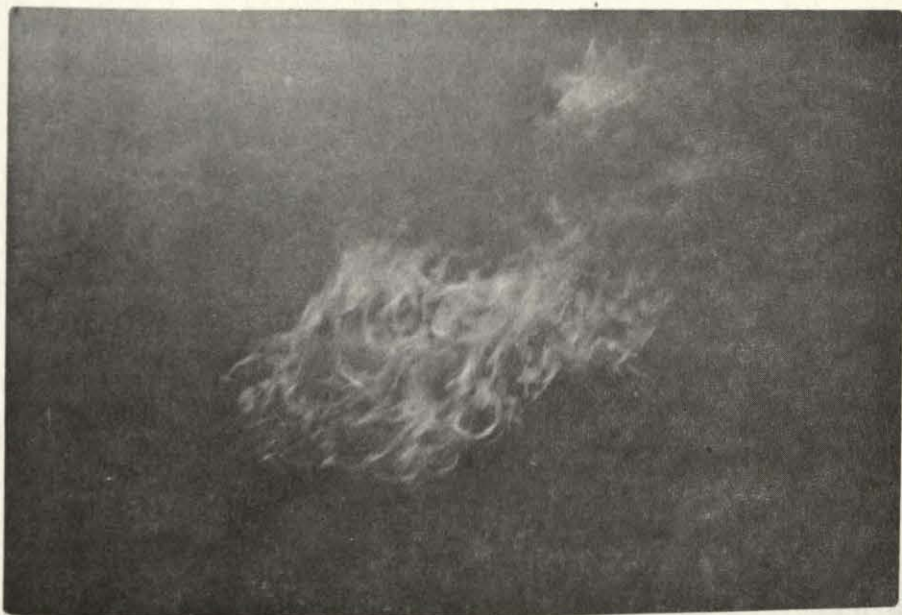
Figure 7. Effect of an Alcohol Fire, 45 Seconds After Ignition.

Figure 8. Alcohol Test 60 Seconds After Ignition.
(Note decrease in visibility)

The alcohol test showed that, for internal fires, smoke may be a greater hazard to the safety of personnel inside the shelter than the fire itself. When the alcohol was poured on the floor and ignited, the fire did not spread and was limited to the area of spillage. The fire continued to burn until the alcohol was consumed and had a tendency to go out unless fanned by a draft. The fire was easily extinguished with a carbon dioxide extinguisher. A fire blanket would probably have been just as effective. However, when the alcohol fire was allowed to persist, a dense black smoke began to form at approximately 30 seconds after ignition, and within a minute, the shelter was filled with smoke and had to be evacuated.

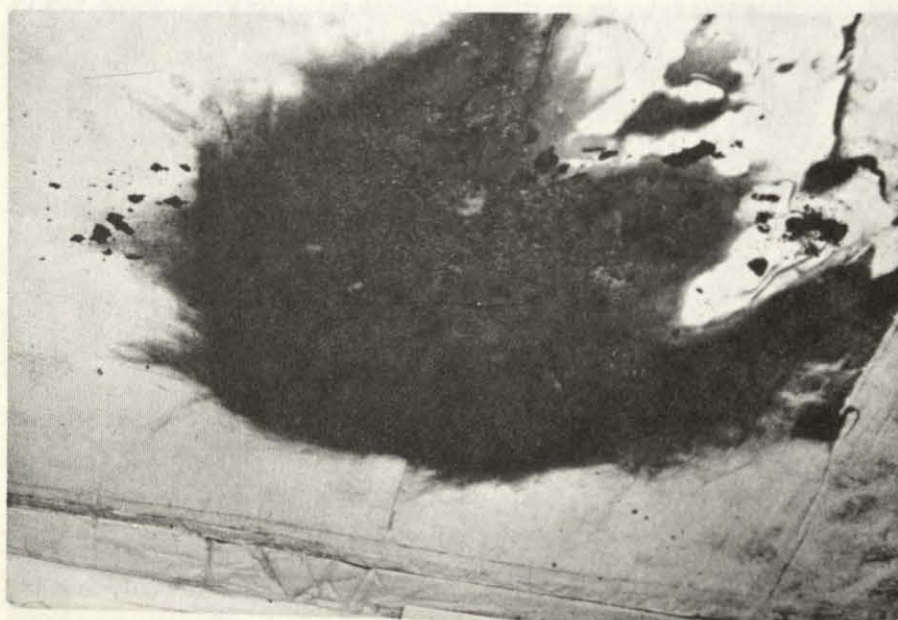
Figure 9. Damage to the Floor Caused by the Alcohol Test.

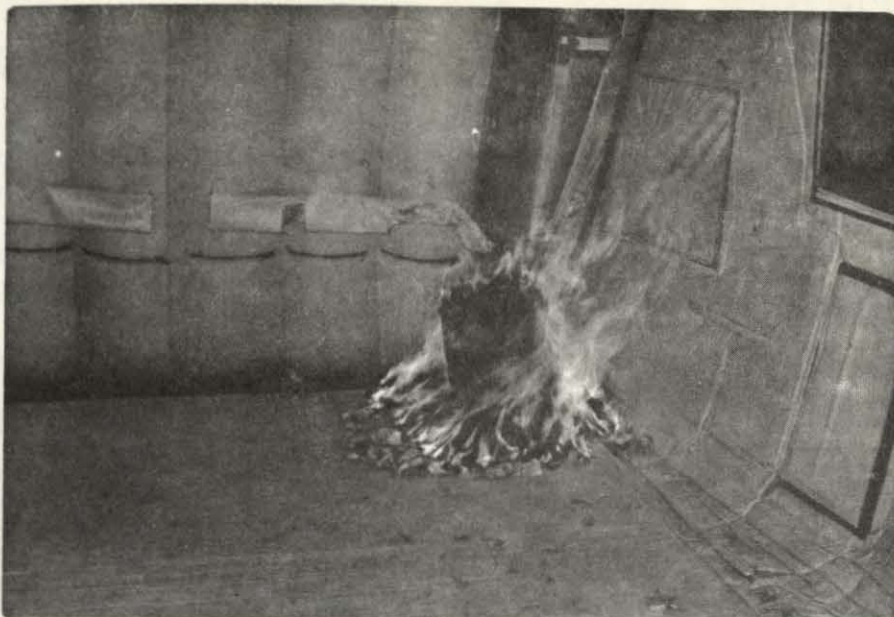
Figure 10. Effect of an Interior Wastebasket Fire.
(Note ruptured inner side wall)

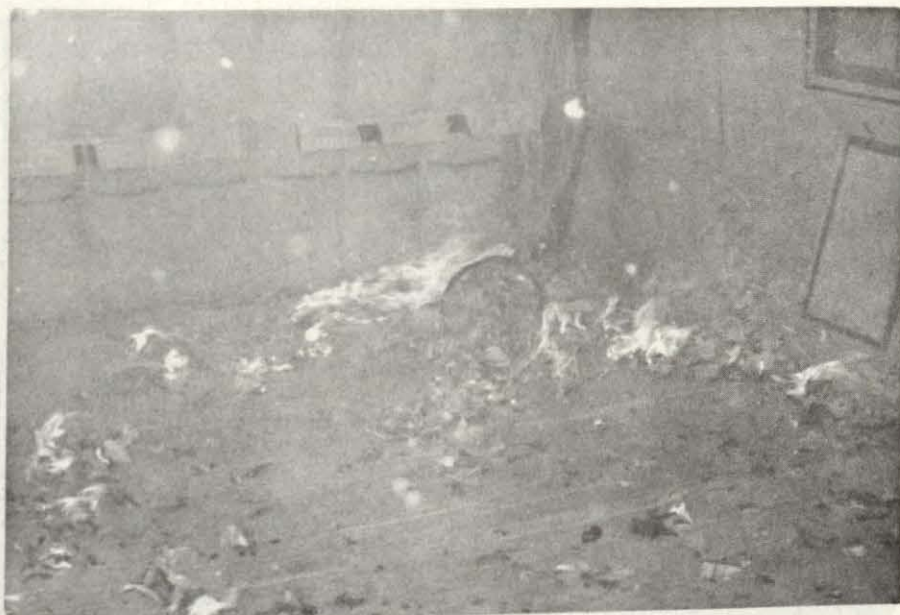
Figure 11. Effect of an Interior Wastebasket Fire, 25 Seconds After Ignition
(Note bladder has exploded, scattering burning debris)

The wastepaper basket tests showed that in those tests where the wastepaper basket was positioned in a corner against the shelter, approximately 25 seconds after ignition of the paper one of the inflated cells would rupture, scattering the flaming newspaper throughout the shelter and propelling the wastepaper basket several feet across the room. When totally unexpected, it was a startling experience. The scattered paper burned out quickly and the fire in the wastepaper basket was easily extinguished. The damage to the cell was severe enough to require more than a "field repair".

7. Wastebaskets should not be placed in a corner or within two feet of a wall.
8. There appeared to be no major differences in the overall response of the three manufacturers' shelters to the fire hazards experienced in this study.

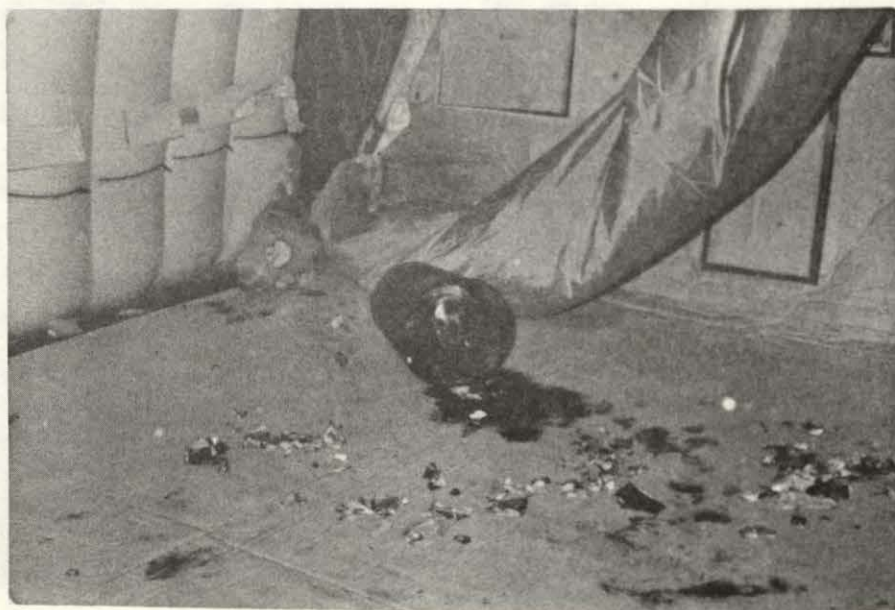
Figure 13. Effect of Interior Wastebasket Fire, Several Minutes After Ignition.
(Note debris on the floor has self-extinguished)

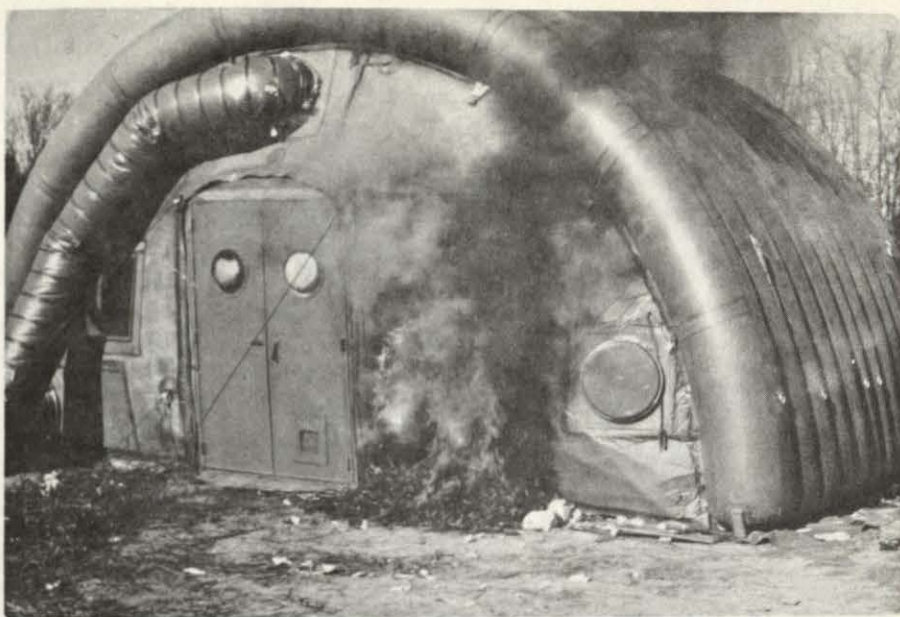
1. Exterior Fire No. 1. (Standard Test) Six pounds (2.7 kg) of shredded newspaper were placed along the outside of, and in contact with, an end panel and ignited. Shelters 3, 4, and 5 were tested in this manner. The shelters ignited, with self-sustaining flames, within 20 to 25 seconds (see Figure 14). In general, the fire produced a hole in the shelters within 30 to 60 seconds after ignition of the paper (see Figures 15 and 16). An inflated cell ruptured in shelter 4 two and one-half minutes after ignition of the paper. The fire in all the shelters was extinguished within three minutes of ignition of the paper in order to save the shelters for additional tests. The fires were easily extinguished with water.

Figure 14. Exterior Fire 1, 6 lbs. of Shredded Newspaper
Approximately 45 Seconds After Ignition.

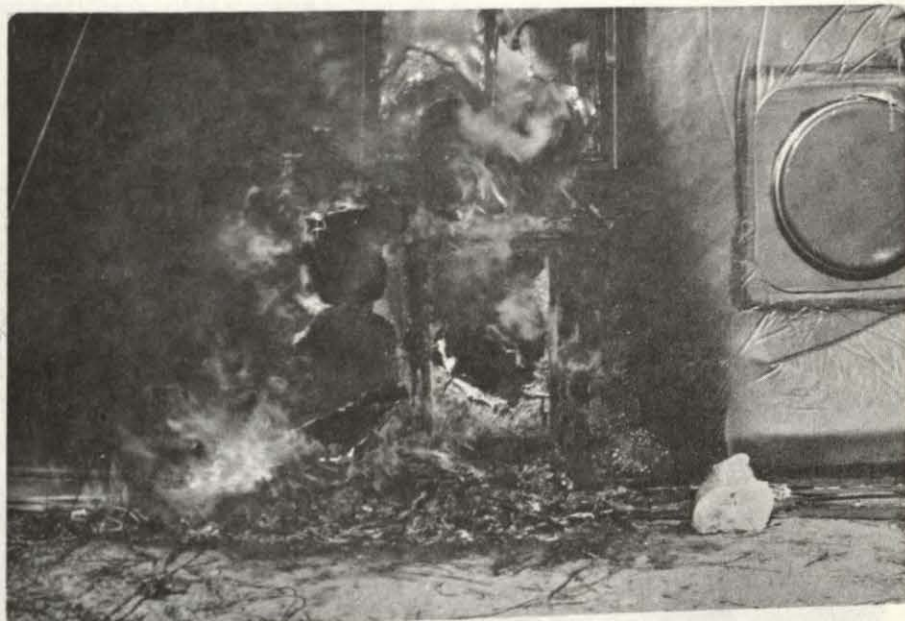
Figure 15. Exterior Fire No. 1, Approximately 75 Seconds After Ignition.

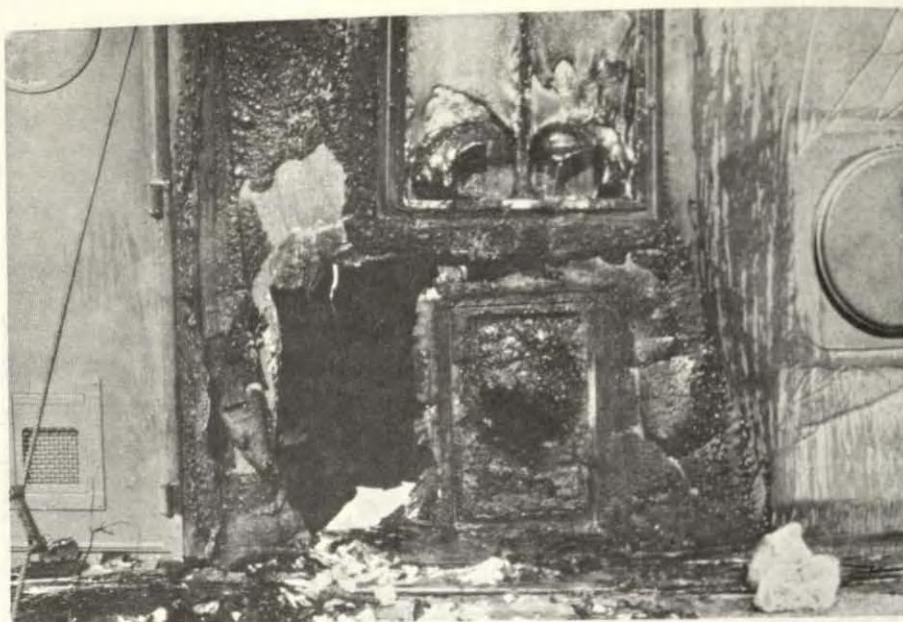
Figure 16. Damage Caused by Exterior Fire No. 1
(Fire Extinguished by H_2O)

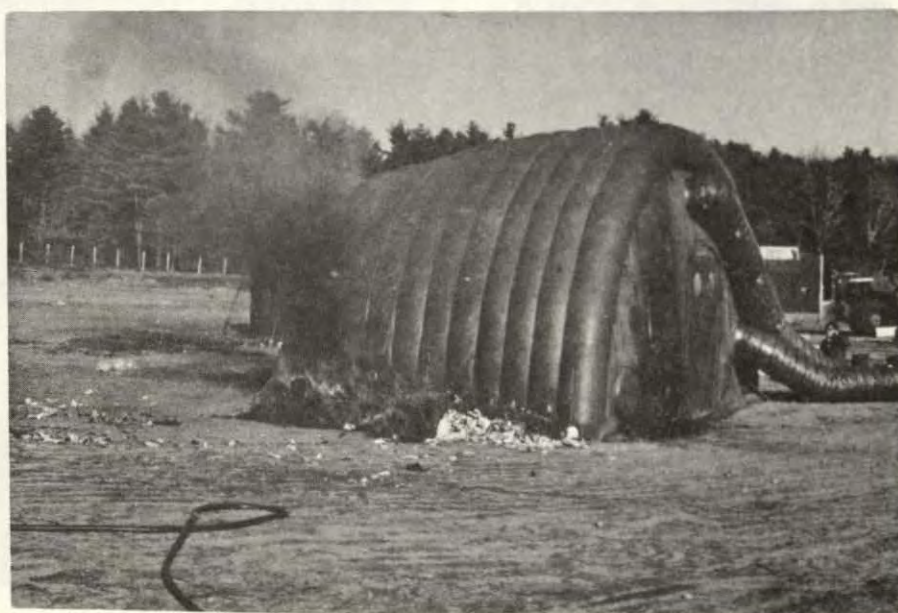
Figure 17. Exterior Fire, No. 2, Approximately 30 Seconds After Ignition
26 lbs. of Shredded Newspaper Along the Inflated Tubes

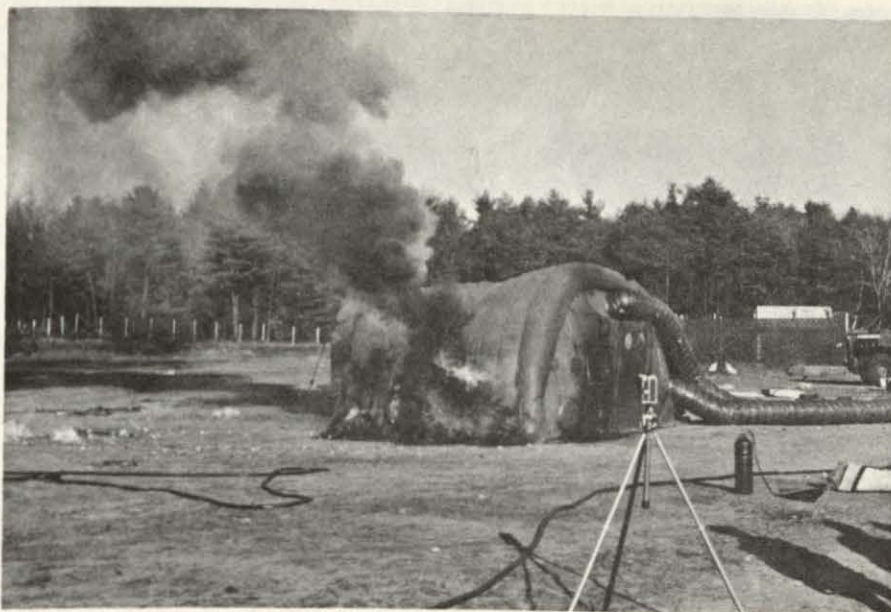
Figure 18. Exterior Fire No. 2, Approximately 50 Seconds After Ignition.

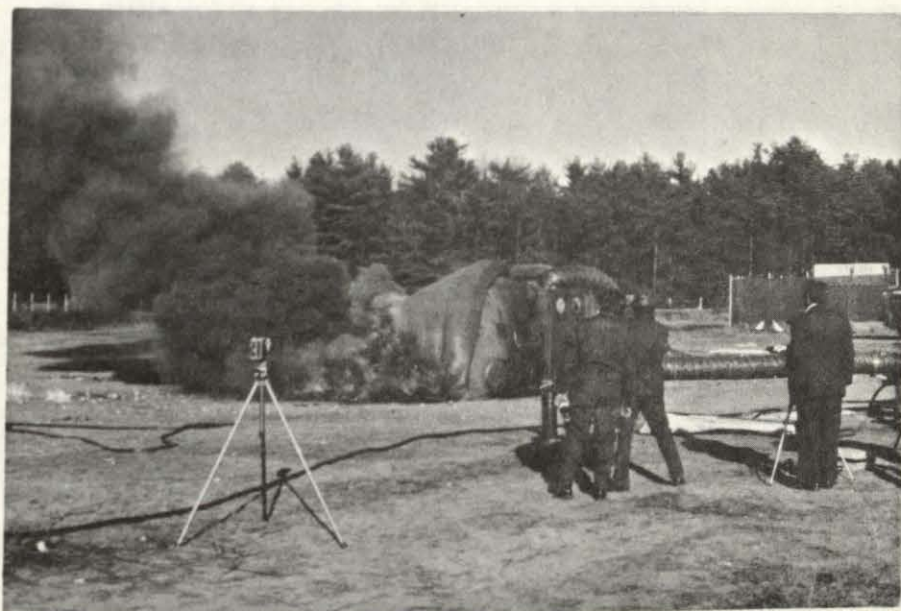
Figure 19. Exterior Fire No. 2, Approximately 2 Minutes After Ignition.

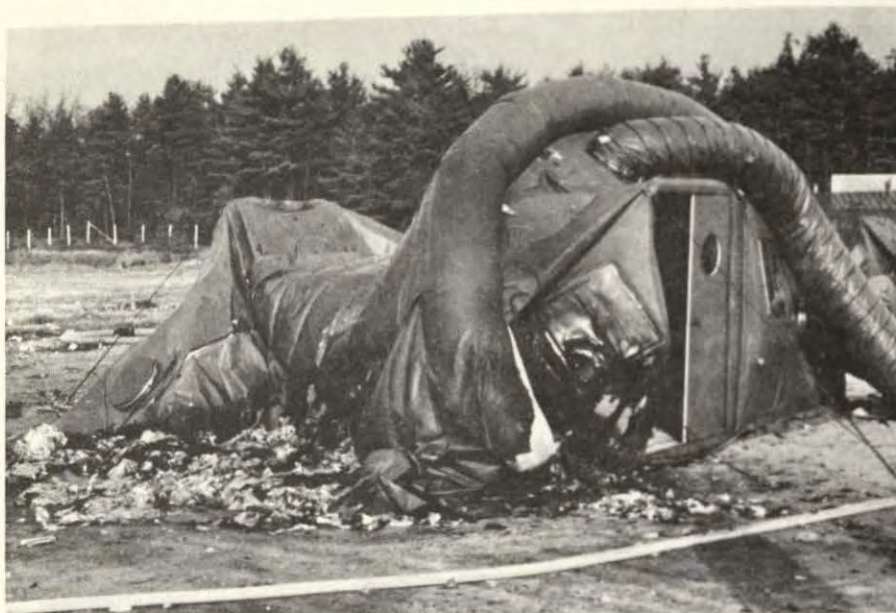
Figure 20. Damage Caused by Exterior Fire No. 2.

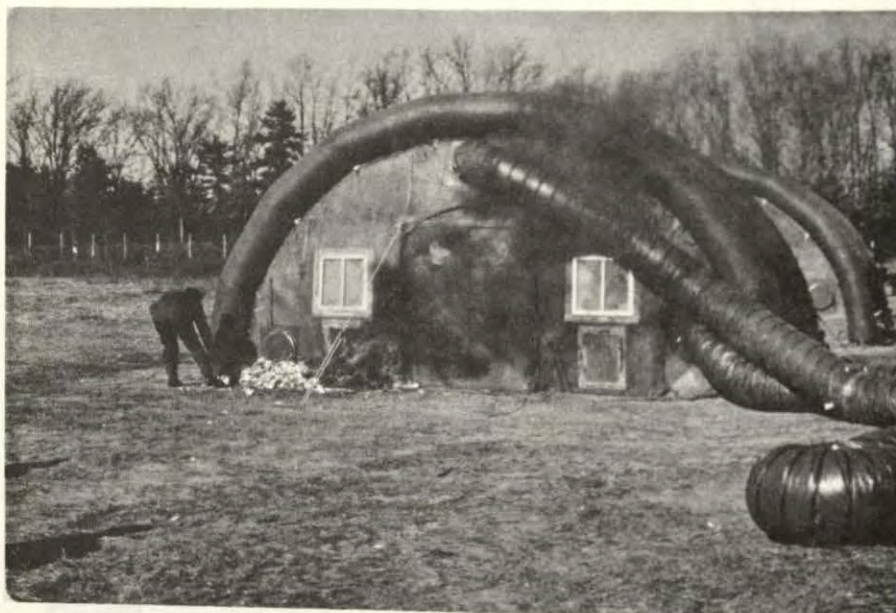
Figure 21. Exterior Fire No. 3, 12 lbs of Shredded Newspaper, several Seconds After Ignition.

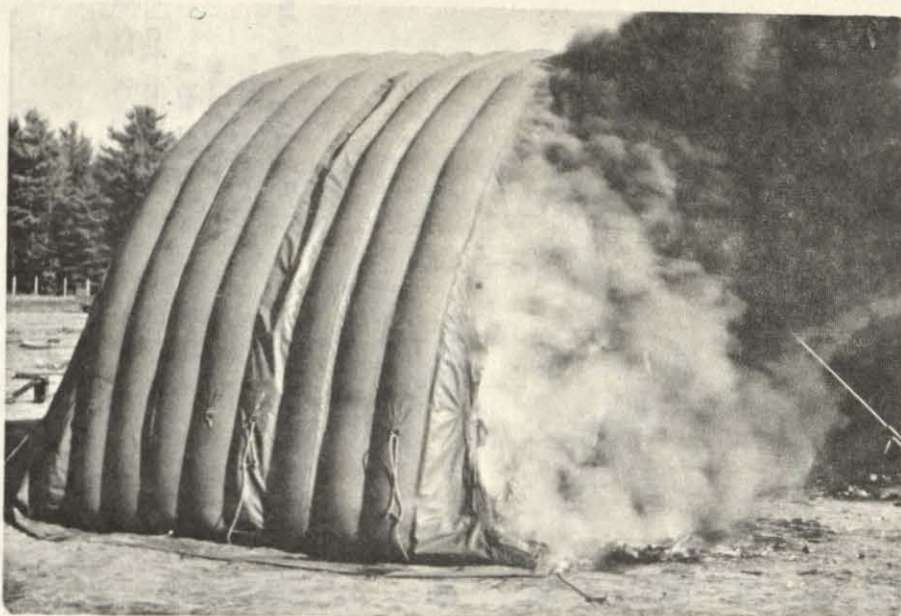
Figure 22. Exterior Fire No. 3, Approximately 2 Minutes After Ignition.

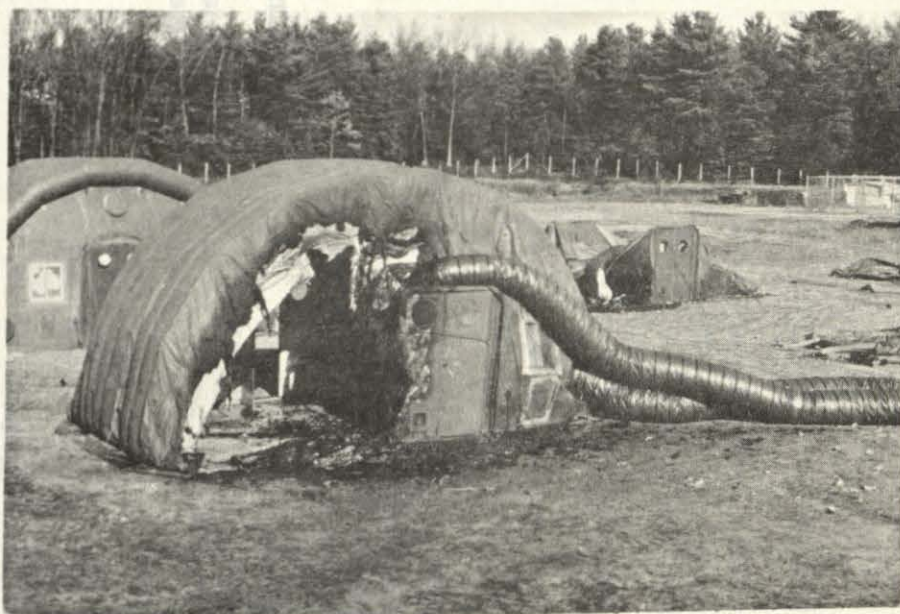
3. Exterior Fire No. 3. Similarly, in order to simulate a large external fire at the end panels, twelve pounds (5.4 kg) of shredded newspaper was placed along the outside of a panel. Shelters 1, 2, and 6 were used for this test. The shelters were ignited with self-sustaining flames 20 to 30 seconds after the ignition of the paper (see Figure 21). With shelters 1 and 6, an end cell exploded 30 seconds after the ignition of the paper. A number of cells ruptured in all the shelters within two to two and one-half minutes after the ignition of the paper (see Figure 22). Shelter 1 was allowed to burn unchecked and the shelter collapsed three minutes after the ignition of the paper. Figure 23 depicts the typical

damage caused to an end panel by this type of fire (Shelter 6).

Figure 23. Damage Caused by Exterior Fire No. 3.
(Fire Extinguished by Water)

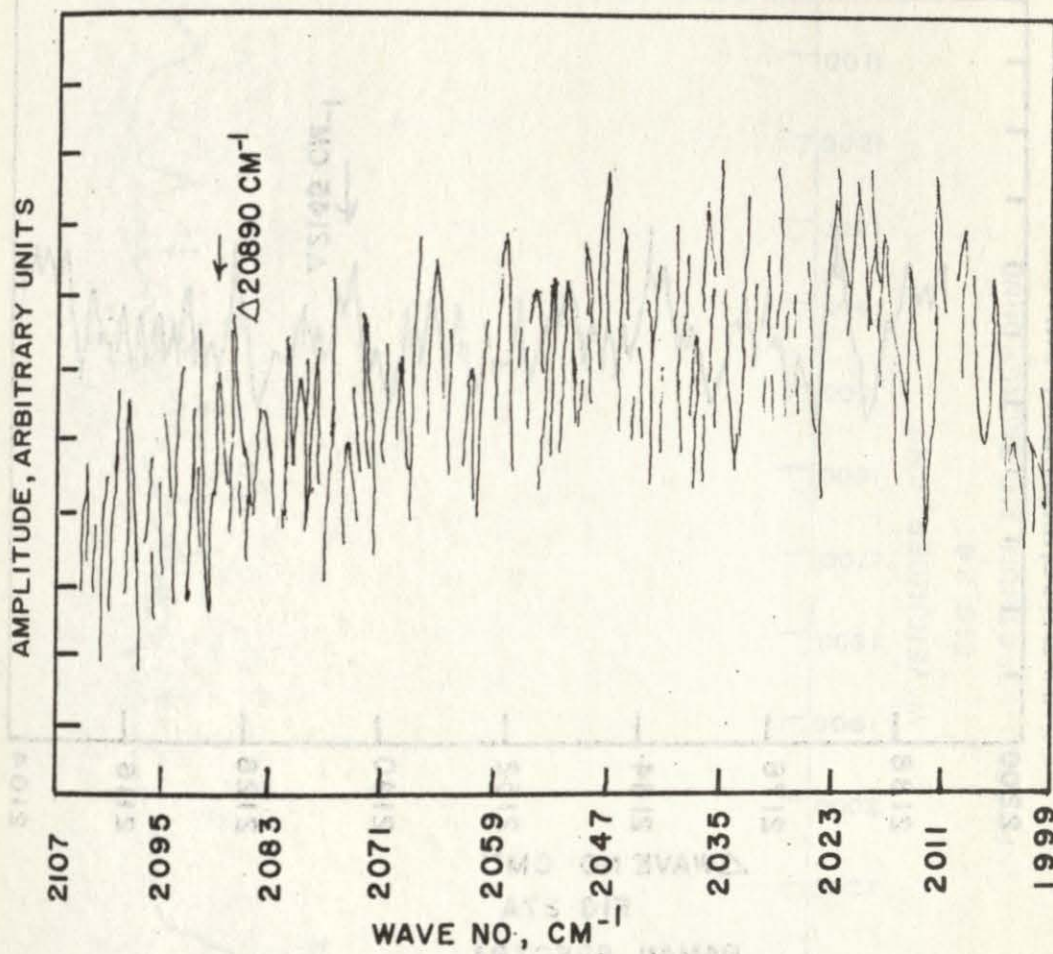
FIG. 27

SCAN RANGE, 2000-2107 CM⁻¹
NO DETECTABLE HCN, 2089 CM⁻¹
SENSITIVITY, 30 X
RAMAN SPECTRA

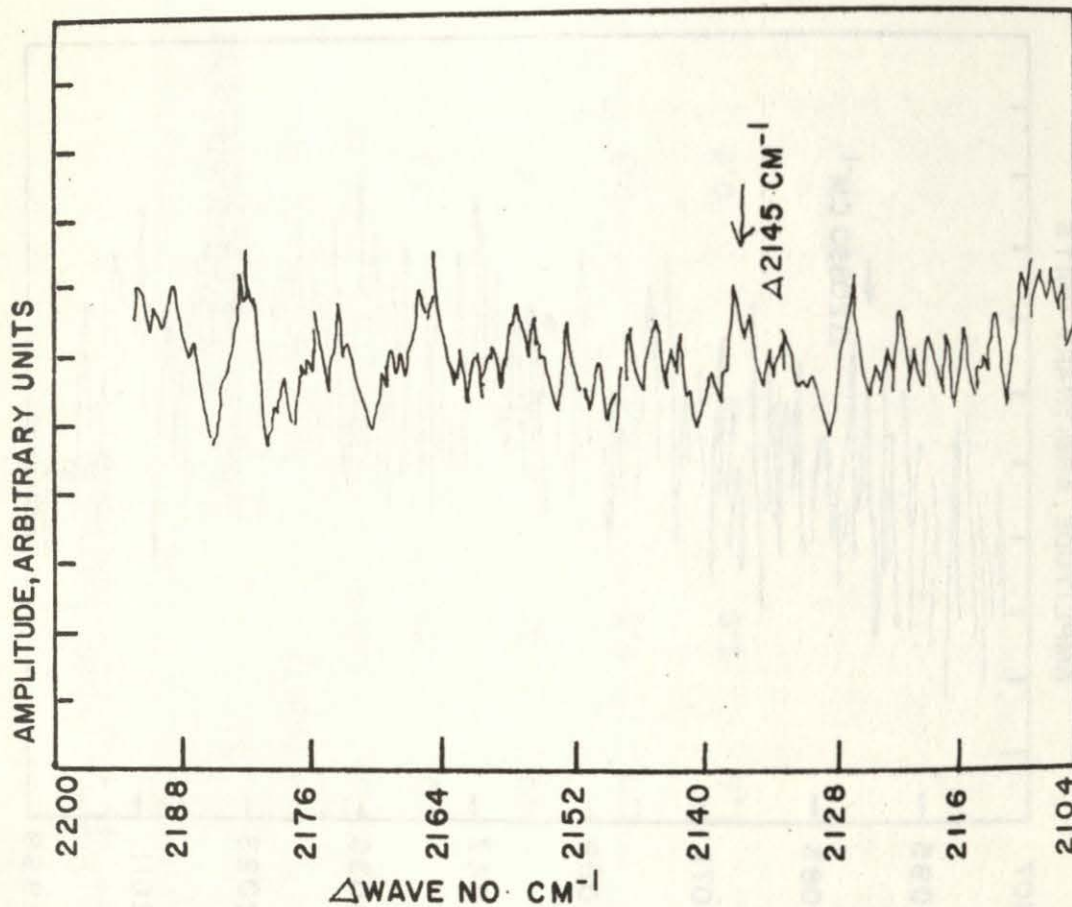
FIG. 27A

NO DETECTABLE CO, 2145 CM^{-1}

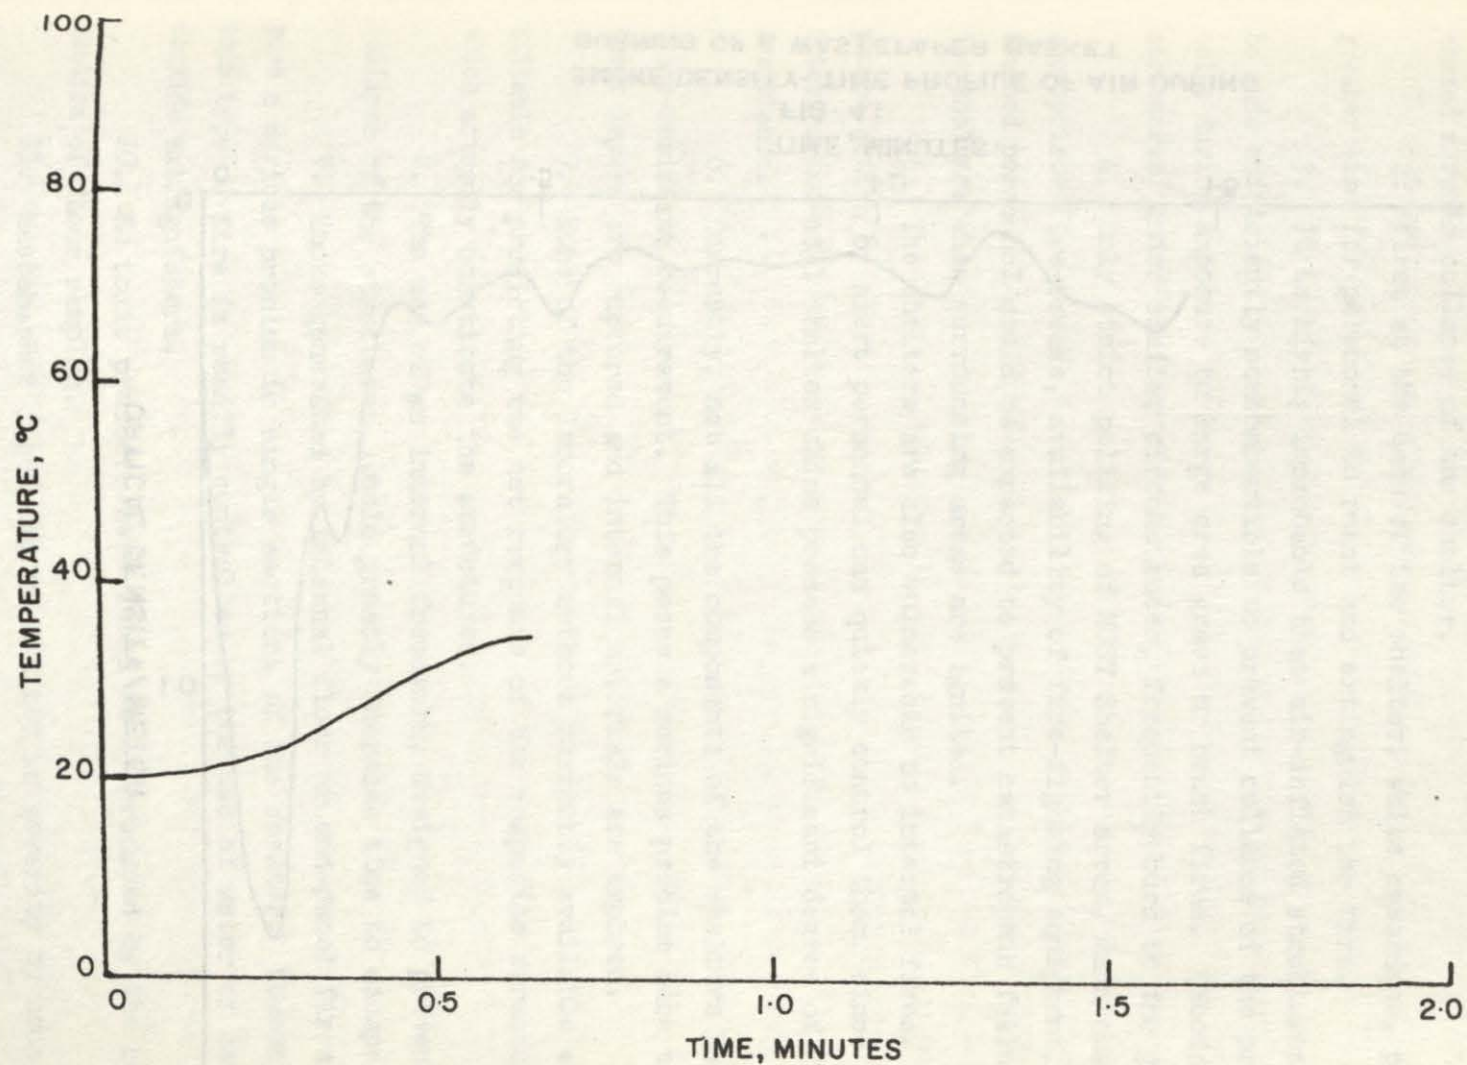
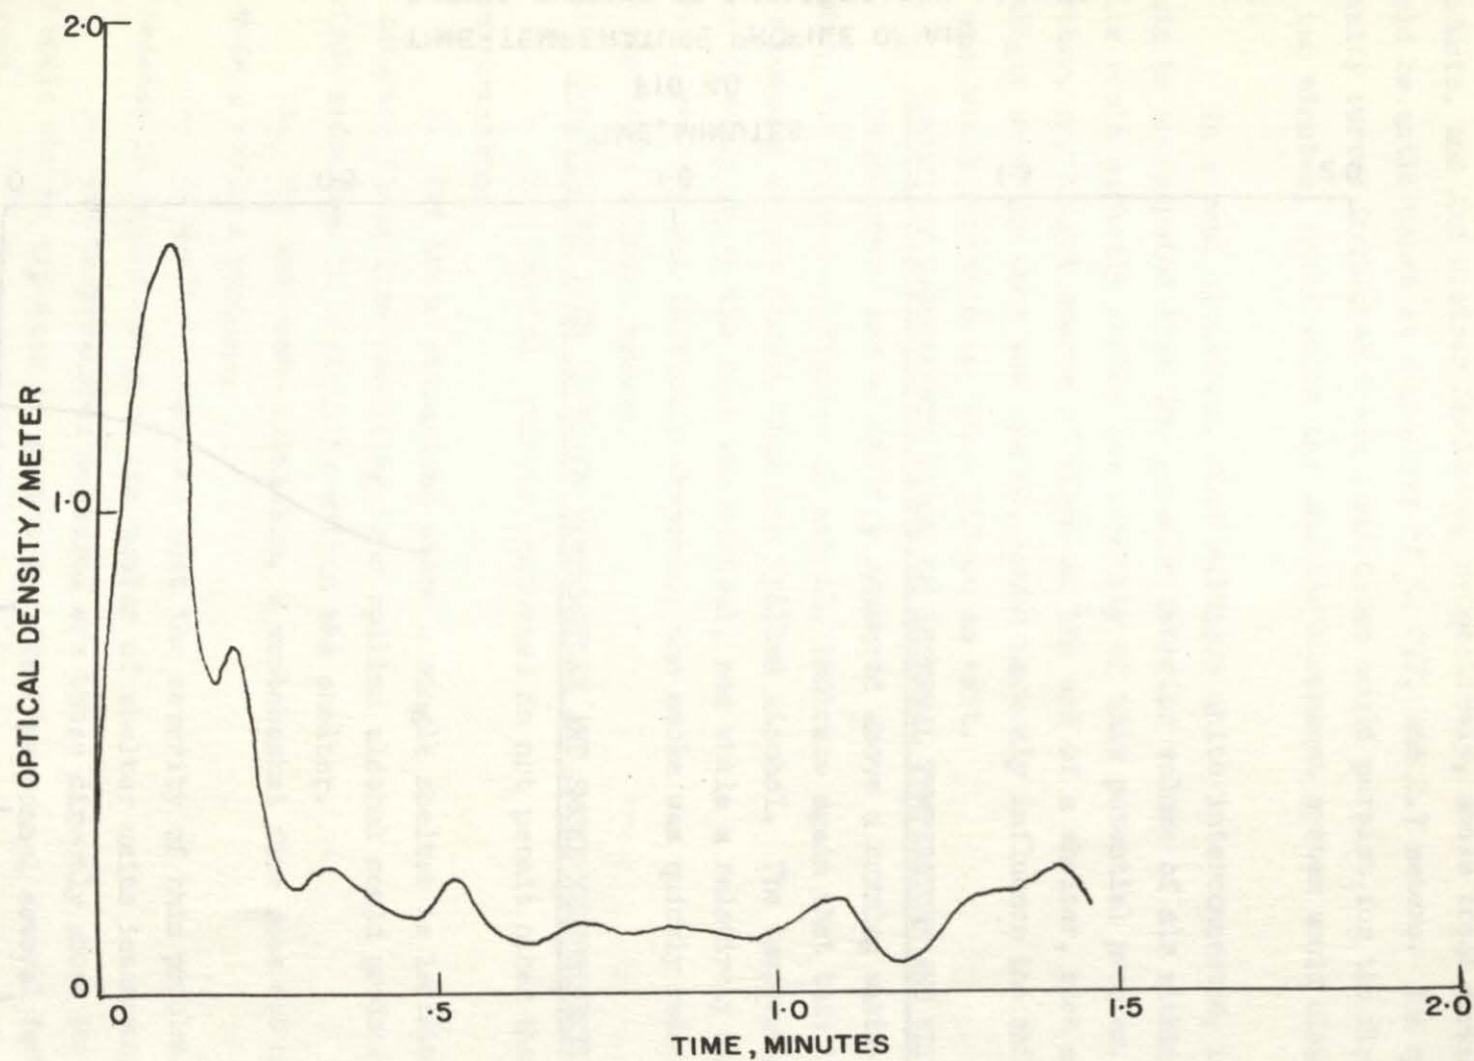
Temperature and visibility measured above a burning wastebasket, the curves of Figures 40 and 41, indicate again that this type fire poses a lesser threat than the spilled alcohol. The temperature rise directly above the fire was minimal, and while a relatively high optical density was initially observed, the smoke was quickly reduced by the shelter's exhaust system.

FIG. 40
TIME-TEMPERATURE PROFILE OF AIR
DURING BURNING OF A WASTEPAPER BASKET

FIG. 41
SMOKE DENSITY-TIME PROFILE OF AIR DURING
BURNING OF A WASTEPAPER BASKET
